NOTICE OF COMPLIANCE/NON-COMPLIANCE

KANSAS DEPARTMENT OF HEALTH AND ENVIRONMENT

Division of Environment
Waste Management Program

TO: Clean Harbors Kansas LLC 03/18/08
2549 N. New York Wichita Ks. 67219-4322 Sedgwick
 Address City State Zip Code County

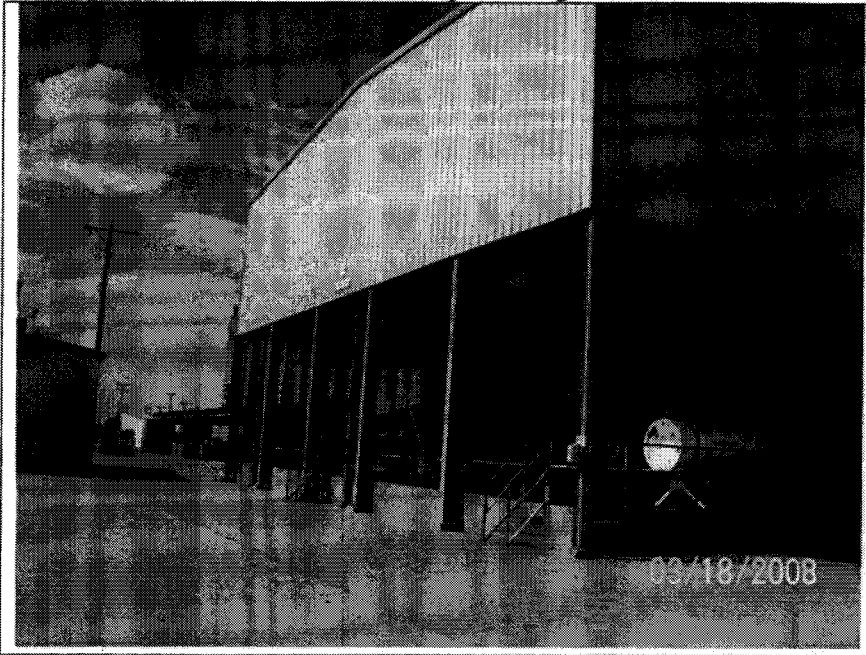
Photo Number: 1 **Photo File#** 987
Date: 03-18-08 @ 2:50 p.m.
Weather: Partly cloudy, cool
Directions: West, Northwest

The center and center right of this photo depicts a view of the Process Area (Tanker Bay Area). In the background, center of this photo is depicted the Transfer-to-Truck Area which is situated west of (behind) the Process Area.

Hazardous Waste Generation Point: The Process Area is situated east of Building C and is not in operation, **photos 1 & 2**. The Process Area is a tanker truck storage area used for overnight parking of tanker trucks of hazardous waste. At one time, hazardous wastes were offloaded into hazardous waste storage tanks and the hazardous waste was processed. There are ten storage tanks and an inoperable drum-cleaning unit. All of the former hazardous waste tanks have been deactivated. **Photos 3 & 4** depict some of the overhead deactivated tanks located in the adjacent Building D.

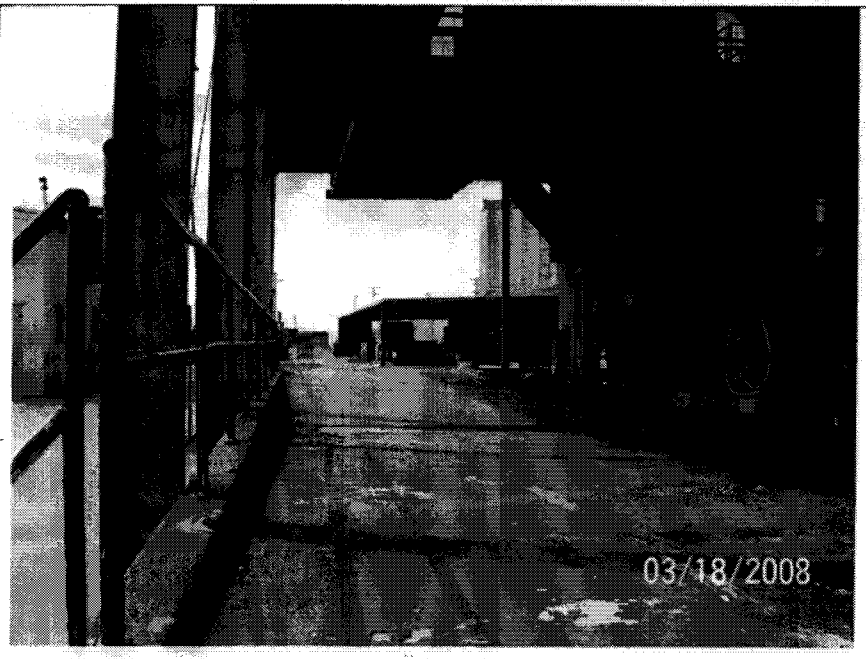
Photo Number: 2 **Photo File#** 992
Date: 03-18-08 @ 3:00 p.m.
Weather: Partly cloudy, cool
Directions: Looking west

This photo was taken of the Process Area beneath the roofed area. Note in the center of photo is the concrete parking lane for tanker trucks to park overnight. The center of the photo also depicts the sump area where precipitation collects, is pumped into drums, labeled as hazardous waste, and stored in Building C. Building C's roofed area can be seen in the background of this photo.

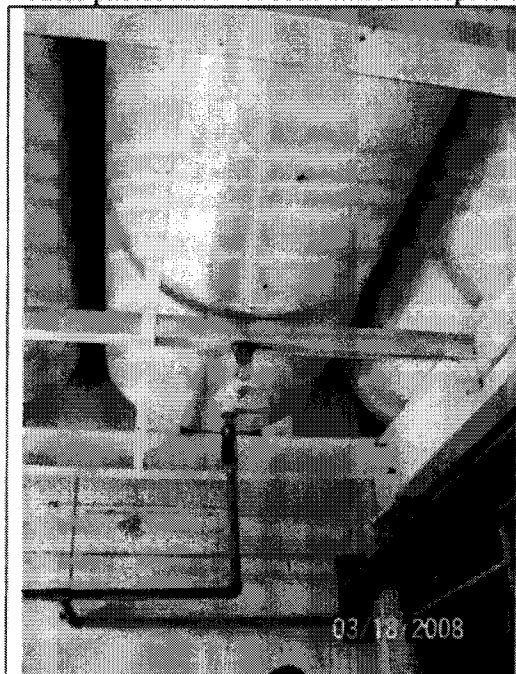
Photo Number: 3 **Photo File#**988

This photo depicts a view looking up towards the ceiling in the Process Area where deactivated hazardous waste tanks are located.

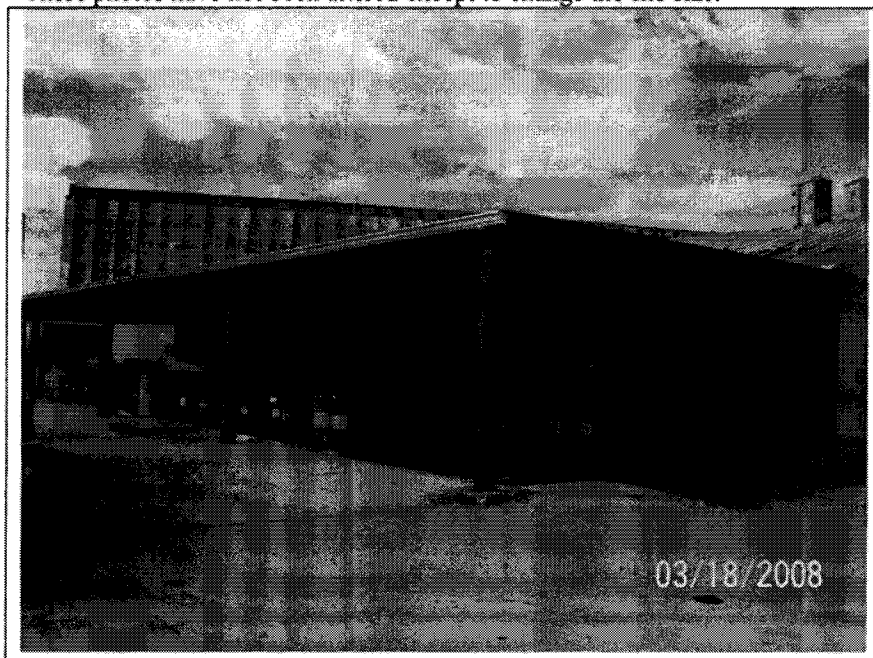
Photo Number: 5 **Photo File #** 995

This photo depicts the Drum Dock area adjacent to Building C. The roofed area is where drums containing hazardous waste are processed and stored for less than 10 days

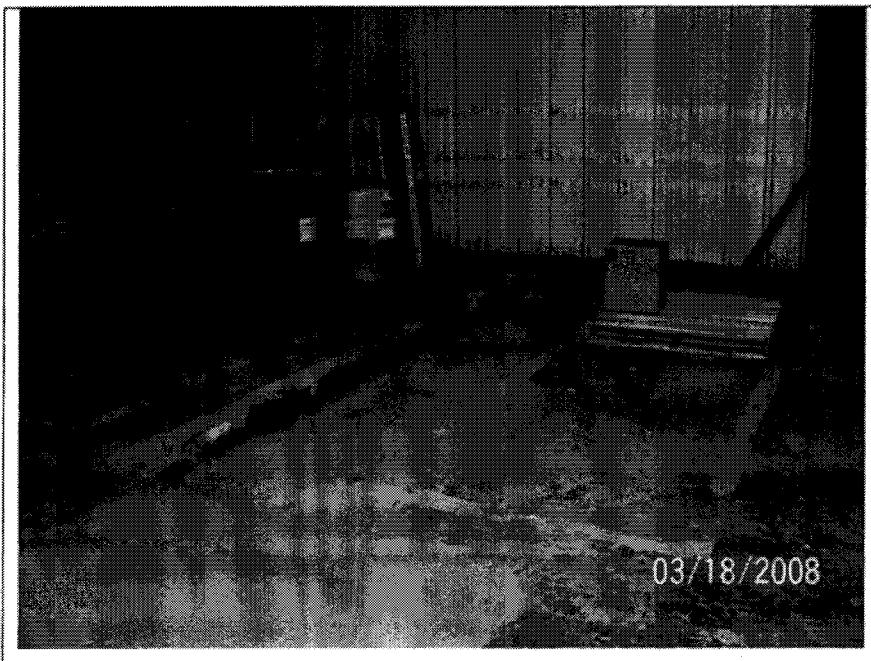
Photo Number: 9 **Photo File#** 1004

Inside Building C: Building C is permitted to store hazardous waste. Inside the building we observed segregated areas dedicated to different hazardous waste streams. Hazardous waste segregated storage areas are delineated by using bright yellow paint and concrete berms. On the day of the inspection, one of the berms was broken, **photos 8-10**. Refer to Part 5.0 Violation Summary of this report.

Violation #1: 40 CFR 264.175(b)/265.175(b)(1)/Permit Section D-2(e)(1): Concrete berm around drums was broken in the secondary containment area, Building C, photos 9-11. Ms. Pulkrabek and I observed the east side of the concrete berm that surrounded 5 drums of hazardous waste and two cardboard tube containers of waste fluorescent lamps had been broken, **photo 9**. This berm also served as a berm for the west side of a cardboard box containing corrosive hazardous waste, **photos 9 & 10**. Mr. Noble stated that about two weeks ago an employee damaged the berm with his loader. Mr. Noble stated that he immediately took photos, telephoned the Compliance and Enforcement Supervisor, Lee Grater, and filed a work order. Mr. Noble stated that the work order has to move up the chain-of-command for approval prior to fixing the berm.

On Thursday, March 27, 2008, Mr. Noble faxed to my office the electronic copy of the work order with the work order's history. **Refer to Attachment C.** *Note that the work order ticket # is 8356, dated March 11, 2008, and states that Cracked berm wall; needs to be repaired/patched.*
